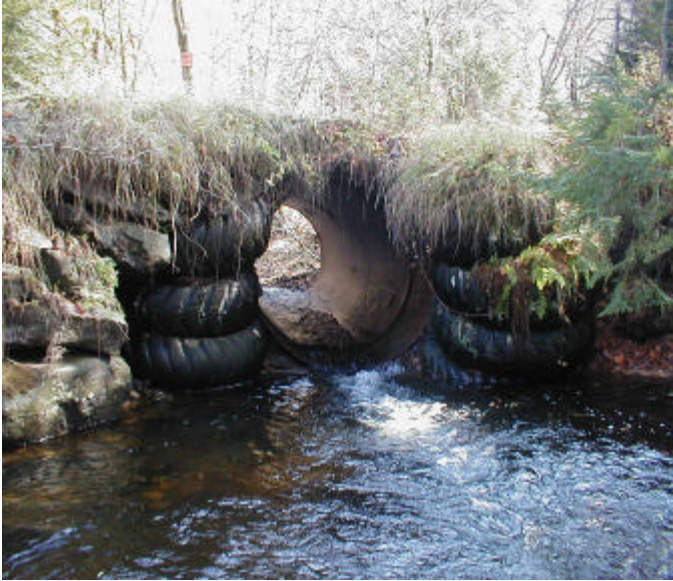
Fisheries cluster:
fish migration barrier = 5

Problem Reach 2.7 Culverts may impede fish passage. If this outlet incises, it will be a serious barrier.

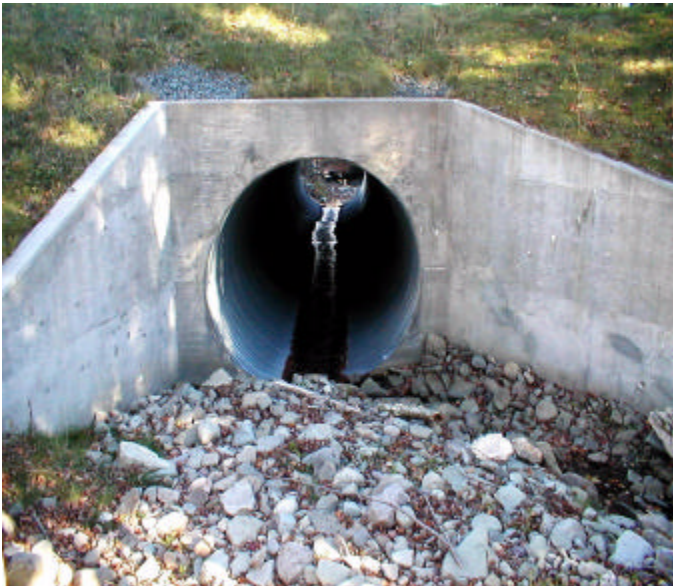
Fisheries cluster:
fish migration barrier = 1

Problem Reach 2.8 This culvert precludes fish passage at all flows. (Even if there was sustained flows in a defined channel instead of this gravel deposition, fish would not be able to traverse the pipe.)

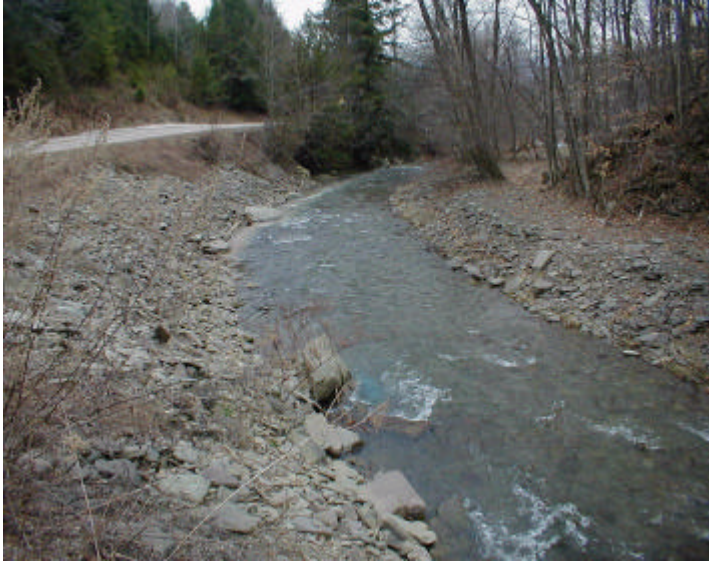
Geomorphic cluster: deviation from bankfull 3, channel condition 1, hydrologic alteration 1, bank stability 3

Fisheries cluster: pool status 1, instream fish cover 1, riparian zone 1, canopy 1

Water quality cluster: water appearance 10, nutrient enrichment 10,

Invertebrate cluster: invertebrate habitat 3

SVAP Aggregate score: 35/11 items scored = 3.2 (poor)

key impacts: geomorphic, fisheries, invertebrates

Problem Reach 2.9 hydrologically altered reach: channelized, widened, rip rapped, incising and entrenched converting a Rosgen B4 → F4 stream type. Note bench along inside of bend & absence of any pool. Dominant substrate is coarse gravel.

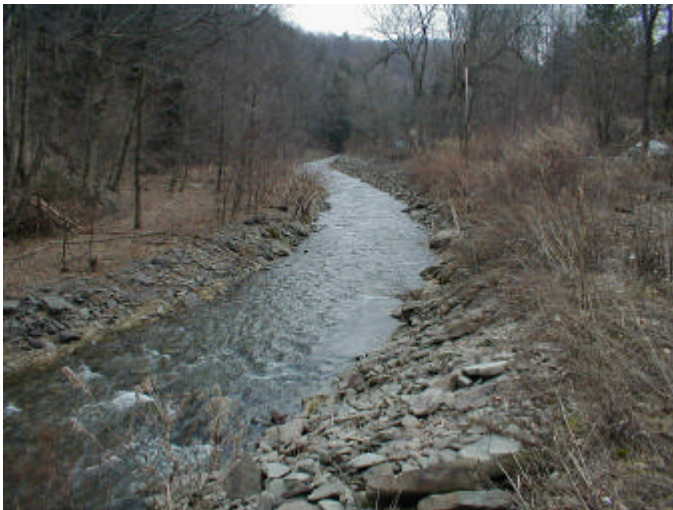
Geomorphic cluster: deviation from bankfull 3, channel condition 1, hydrologic alteration 3, bank stability 3

Fisheries cluster: pool status 1, instream fish cover 3, riparian zone 10, canopy 1

Water quality cluster: water appearance 10, nutrient enrichment 10,

Invertebrate cluster: invertebrate habitat 7

SVAP Aggregate score: 56/11 items scored = 5.1 (poor)

key impacts: geomorphic, fisheries

Problem Reach 3.0 Example of a channelized, rip rapped stream converting a B4 channel to an F4.

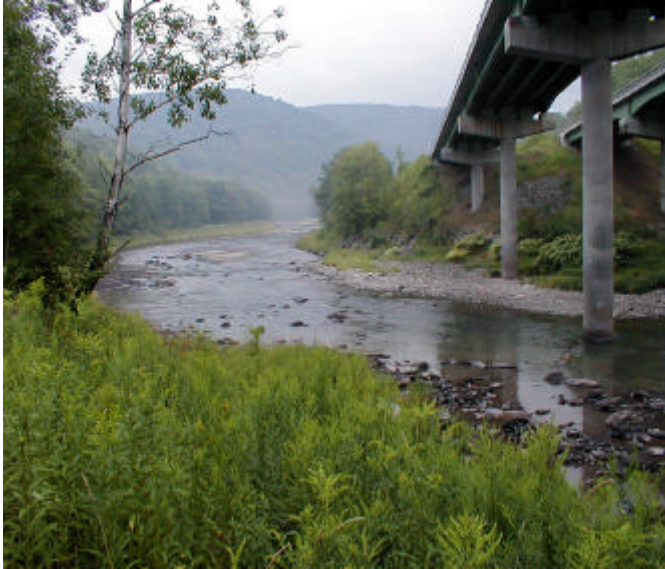
Geomorphic cluster: deviation from bankfull 1, channel condition 1, hydrologic alteration 1, bank stability 7

Fisheries cluster: pool status 1, instream fish cover 1, riparian zone 1, canopy 1

Water quality cluster: water appearance 10, nutrient enrichment 10,

Invertebrate cluster: invertebrate habitat 7

SVAP Aggregate score: 41/11 items scored = 3.7 (poor)

key impacts: geomorphic, fisheries

Problem Reach 3.1 hydrologically altered reach: with pool loss on bend, channelized, widened, entrenched F3 stream type. Dominant substrate is cobble.

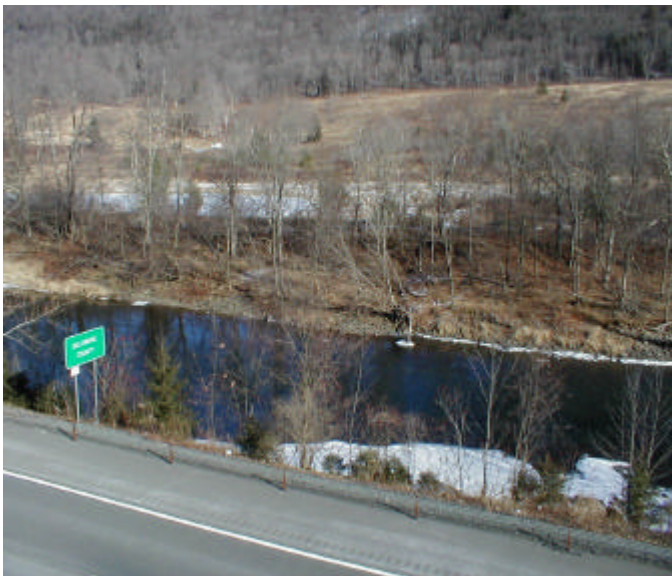
Geomorphic cluster: deviation from bankfull 10, channel condition 1, hydrologic alteration 1, bank stability 1

Fisheries cluster: pool status 7, instream fish cover 7, riparian zone 1, canopy 1

Water quality cluster: water appearance 10, nutrient enrichment 10,

Invertebrate cluster: invertebrate habitat 7

SVAP Aggregate score: 56/11 items scored = 5.1 (fair)

key impacts: geomorphic > fisheries

Problem Reach 3.2 Example of erosion on an inside bend on a Rosgen F4 stream caused by meander loss and hardening the outer bank due to road placement. Note also migration of tree line as bankfull is lowered.
