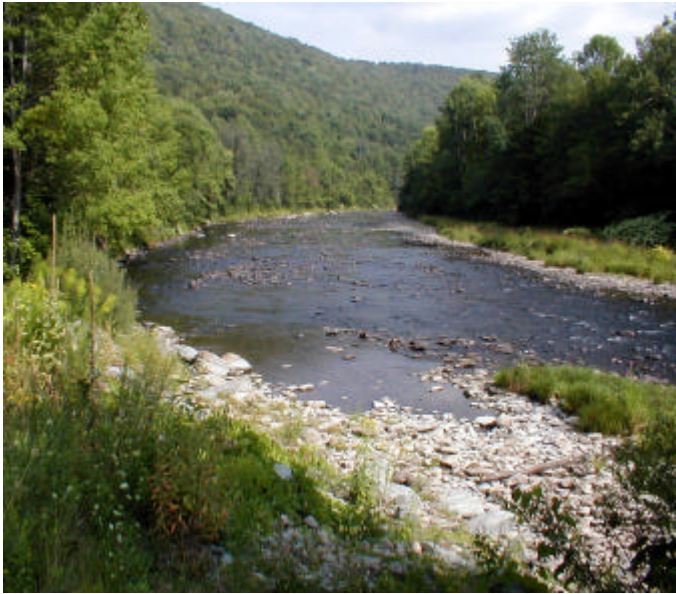
Geomorphic cluster: deviation from bankfull 1, channel condition 3 (aggradation criterion), hydrologic alteration 10, bank stability 10

Fisheries cluster: pool status 7, instream fish cover 3, riparian zone 10, canopy 1

Water quality cluster: water appearance 10, nutrient enrichment 10

Invertebrate cluster: invertebrate habitat 7

SVAP Aggregate score: 72/11 items scored = 6.5 (fair)

key impacts: geomorphic, fisheries

Problem Reach 1.9 Example of an over wide reach, aggrading on a Rosgen F4 stream during extreme low flow conditions. Dominant substrate is coarse gravel.

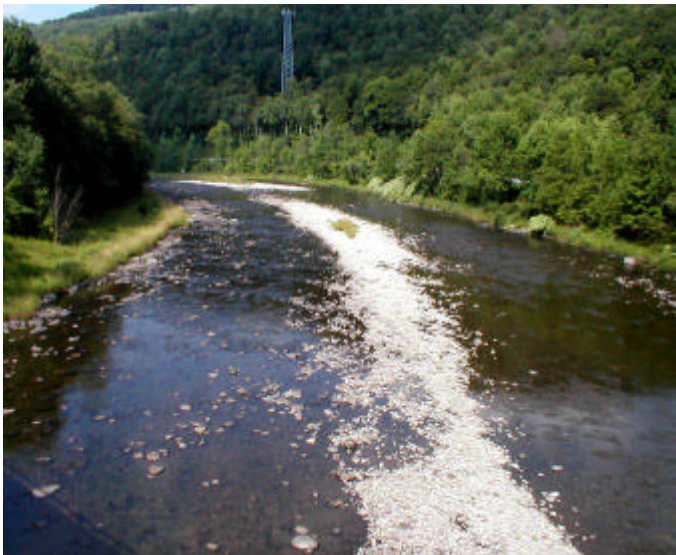
Geomorphic cluster: deviation from bankfull 1, channel condition 3 (aggradation criterion), hydrologic alteration 3, bank stability 10

Fisheries cluster: pool status 7, instream fish cover 3, riparian zone 10, canopy 1

Water quality cluster: water appearance 10, nutrient enrichment 10

Invertebrate cluster: invertebrate habitat 7

SVAP Aggregate score: 65/11 items scored = 5.9 (poor)

key impacts: geomorphic, fisheries

Problem Reach 2.0 Example of an incised over wide reach, with mid channel deposition on a Rosgen F4 stream reach during extreme low flow conditions. Dominant substrate is coarse gravel.

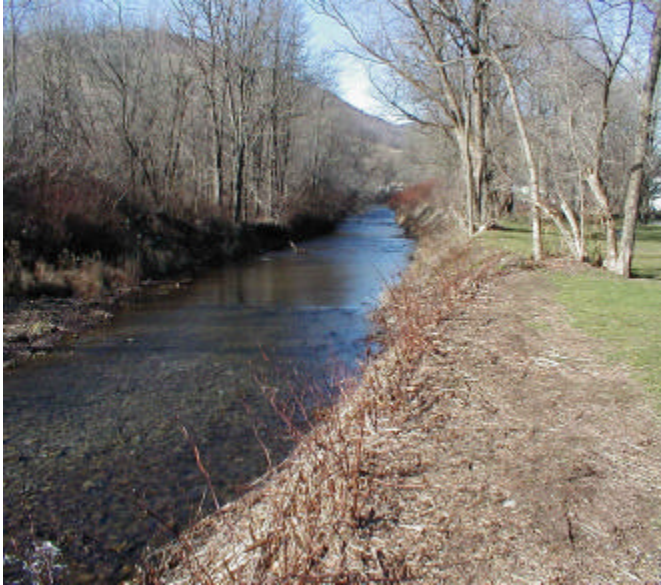
Geomorphic cluster: deviation from bankfull 3, channel condition 7, hydrologic alteration 7 (limited incision) , bank stability 10

Fisheries cluster: pool status 7, instream fish cover 3, riparian zone 1, canopy 1

Water quality cluster: water appearance 10, nutrient enrichment 10,

Invertebrate cluster: invertebrate habitat 7

SVAP Aggregate score: 66/11 items scored = 6.6 (fair)

key impacts: geomorphic, fisheries

Problem Reach 2.1 Example of poor riparian zone (right foreground), fair riparian zone (right background), and optimal riparian zone (left bank) on an over straight Rosgen B4 stream. Note channel response with reduction in vegetation, it widens!

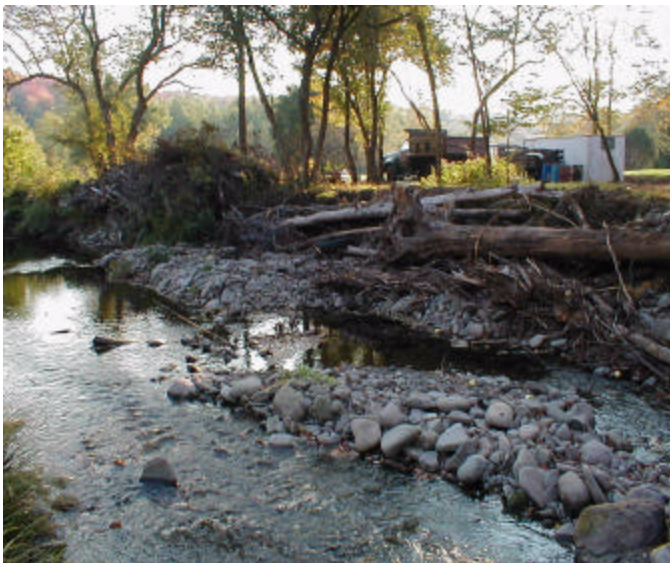
Geomorphic cluster: deviation from bankfull 1, channel condition 1, hydrologic alteration 3, bank stability 1

Fisheries cluster: pool status 3, instream fish cover 1, riparian zone 1, canopy 1

Water quality cluster: water appearance 10, nutrient enrichment 10

Invertebrate cluster: invertebrate habitat 7

SVAP Aggregate score: 37/11 items scored = 3.4 (poor)

key impacts: geomorphic, fisheries

Problem Reach 2.2 Example of a poor riparian vegetation with an eroded high bank below flood deposited LWD & cobble. Channel is an over wide and incised Rosgen B3 stream reach

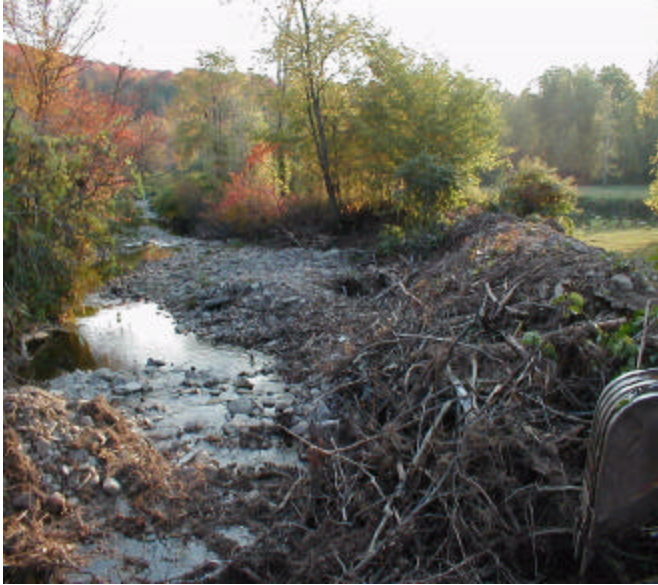
Geomorphic cluster: deviation from bankfull 1, channel condition 1 (active downcutting & widening), hydrologic alteration 1, bank stability 3

Fisheries cluster: pool status 3, instream fish cover 3, riparian zone 1, canopy 1

Water quality cluster: water appearance 10, nutrient enrichment 10

Invertebrate cluster: invertebrate habitat 7

SVAP Aggregate score: 40/11 items scored = 3.6 (poor)

key impacts: geomorphic, fisheries

Problem Reach 2.3 Example of an actively incising, bermed over wide reach on a Rosgen B4 stream during extreme low flow conditions. Dominant substrate is coarse gravel.

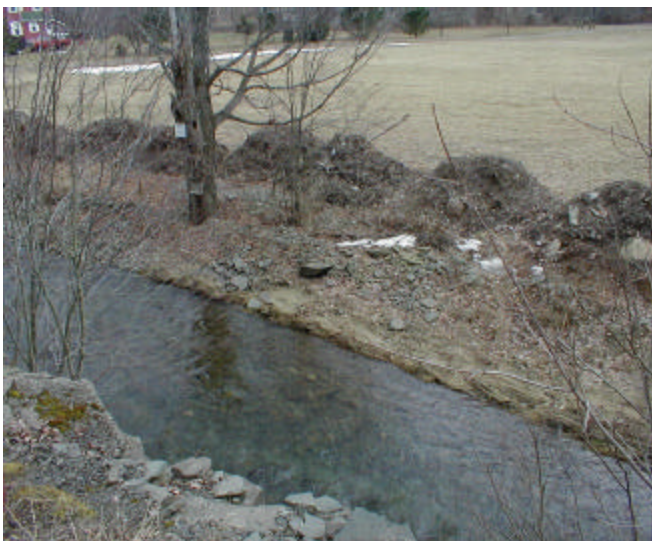
Geomorphic cluster: deviation from bankfull 10, channel condition 3, hydrologic alteration 1, bank stability 3

Fisheries cluster: pool status 3, instream fish cover 3, riparian zone 1, canopy 1

Water quality cluster: water appearance 10, nutrient enrichment 10

Invertebrate cluster: invertebrate habitat 7

SVAP Aggregate score: 52/11 items scored = 4.7 (poor)

key impacts: geomorphic, fisheries

Problem Reach 2.4 Example of a bermed reach with poor riparian zone, Rosgen F3 stream. Dominant substrate is cobble.

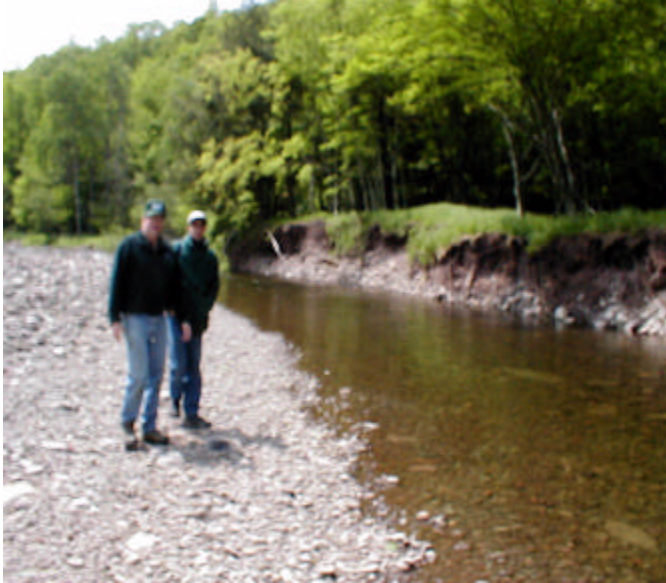
Geomorphic cluster: deviation from bankfull 1, channel condition 1, hydrologic alteration 3, bank stability 1

Fisheries cluster: pool status 1, instream fish cover 1, riparian zone 10, canopy 1

Water quality cluster: water appearance 10, nutrient enrichment 10

Invertebrate cluster: invertebrate habitat 3

SVAP Aggregate score: 42/11 items scored = 3.8 (fair)

key impacts: geomorphic, fisheries, invertebrate

Problem Reach 2.5 Example of an over wide reach, aggrading, with pool loss, actively eroding bank, and overly large unvegetated point bar on a Rosgen C4 stream during low flow conditions. Dominant substrate is medium gravel.

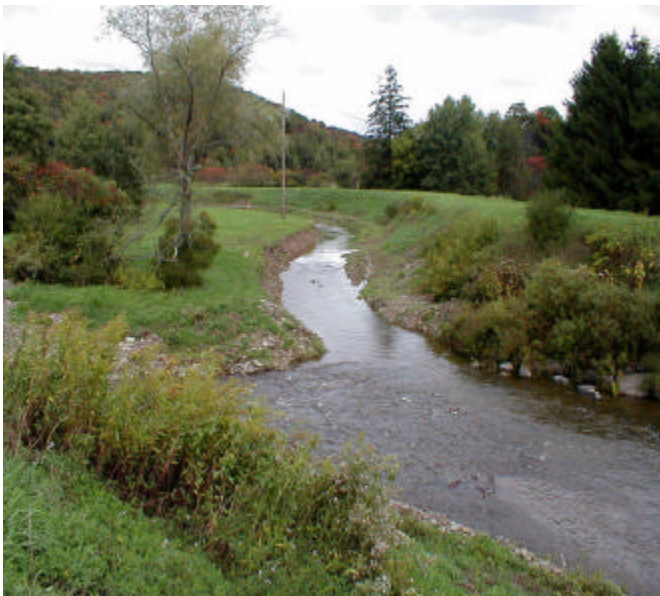
Geomorphic cluster: deviation from bankfull 3, channel condition 7. hydrologic alteration 1, bank stability 1

Fisheries cluster: pool status 1, instream fish cover 1, riparian zone 1, canopy 1

Water quality cluster: water appearance 10, nutrient enrichment 10

Invertebrate cluster: invertebrate habitat 1

SVAP Aggregate score: 31/11 items scored = 2.8 (poor)

key impacts: geomorphic, fisheries, invertebrate

Problem Reach 2.6 Example of an, active erosion on outer bank of tributary due to lack of vegetation & gravel mining on an overwide Rosgen C4 stream reach. Note large levee on right.
