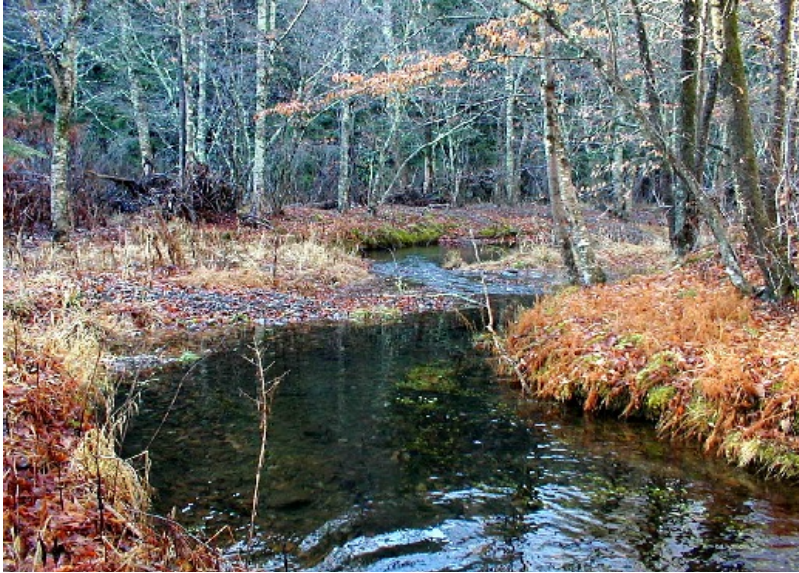
Reference Reach 1.1 Excellent example of a low gradient woodland meandering Rosgen C4 stream of reference reach quality. Dominant substrate is gravel.

Geomorphic cluster: deviation from bankfull 10, channel condition 10, hydrologic alteration 10, bank stability 10

Fisheries cluster: pool status 7*, instream fish cover 8*, riparian zone 10, canopy 10, fish barriers 10

Water quality cluster: water appearance 10, nutrient enrichment 10,

Invertebrate cluster: invertebrate habitat 10

SVAP Aggregate score: 115/12 items scored = 9.6 (excellent)

* lower scores were assigned only for pool depths and for in stream fish cover

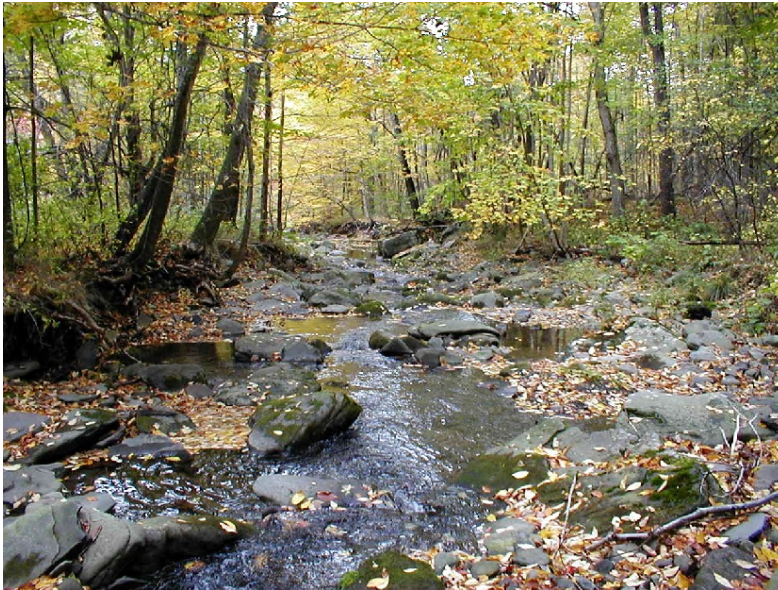
Reference Reach 1.2 Excellent example of a Rosgen Class B3 stream during extreme drought, note channel roughness, bankfull elevation is at the lower scour zone along the base of the larger trees. Dominant substrate is large cobble. (note boundary roughness!)

Geomorphic Cluster: Wbkfl = 10, channel condition = 10, Hydrologic Alteration = 10, Bank stability = 10

Fisheries Cluster: pool status= 8, instream fish cover = 10, riparian zone = 10, Canopy = 10, Fish Barriers = 10

Water Quality Cluster: appearance = 10, nutrients = 10,

Invertebrate Cluster: invertebrate habitat = 10

SVAP Average Score for reach: = 9.8

status = excellent

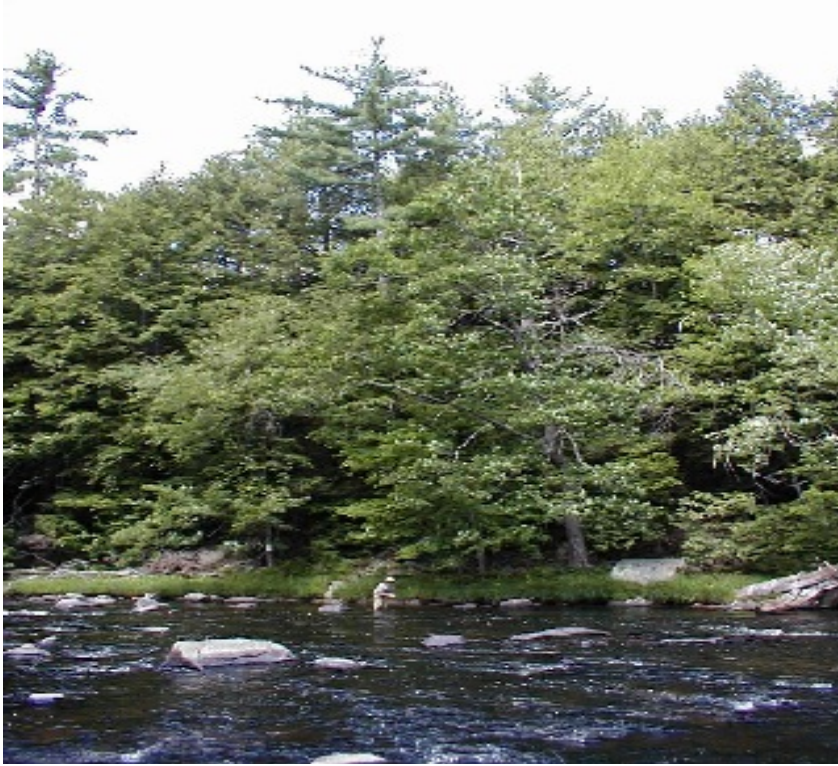
Reference reach 1.3: stable boulder, cobble channel, excellent riparian zone
Geomorphic cluster: channel condition 10, hydrologic alteration 10, bank stability 10
Fisheries cluster: instream fish cover 8*, riparian zone 10, fish barriers 10
Water quality cluster: water appearance 10,
Invertebrate cluster: invertebrate habitat 10
 SVAP Aggregate score: 78/8 items = 9.75 (excellent)

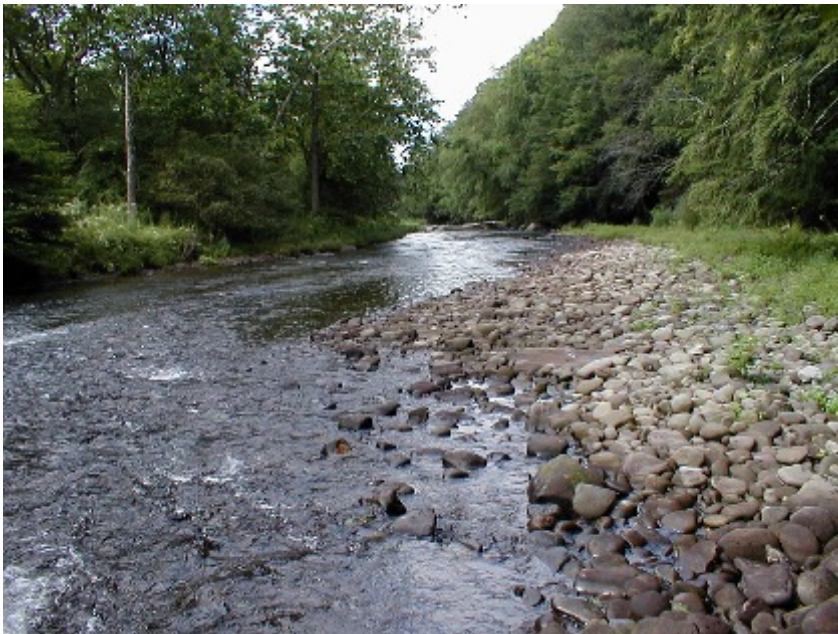
Reference reach 1.4: stable cobble channel, excellent point bar (in low flow), excellent riparian zone
Geomorphic cluster: channel condition 10, hydrologic alteration 10, bank stability 10
Fisheries cluster: instream fish cover 10, riparian zone 10, fish barriers 10
Water quality cluster: water appearance 10,
Invertebrate cluster: invertebrate habitat 10
 SVAP Aggregate score: 80/8 items = 10 (excellent)
 RR 2

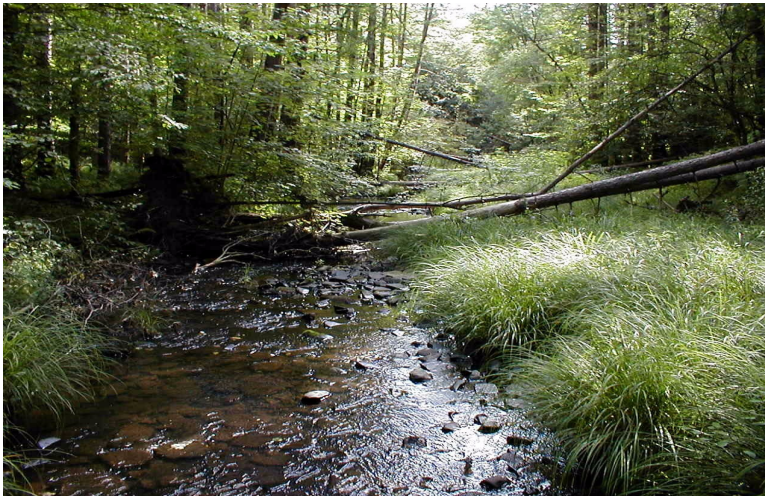
Reference Reach 1.5 Excellent example of a medium gradient woodland Rosgen C4 stream of reference reach quality with an appropriate amount of LWD. Dominant substrate is coarse gravel.

Geomorphic cluster: deviation from bankfull 10, channel condition 10, hydrologic alteration 10, bank stability 10

Fisheries cluster: pool status 3, instream fish cover 10, riparian zone 10, canopy 10,

Water quality cluster: water appearance 10, nutrient enrichment 10,

Invertebrate cluster: invertebrate habitat 10

SVAP Aggregate score: 103/11 items scored = 9.4 (excellent)

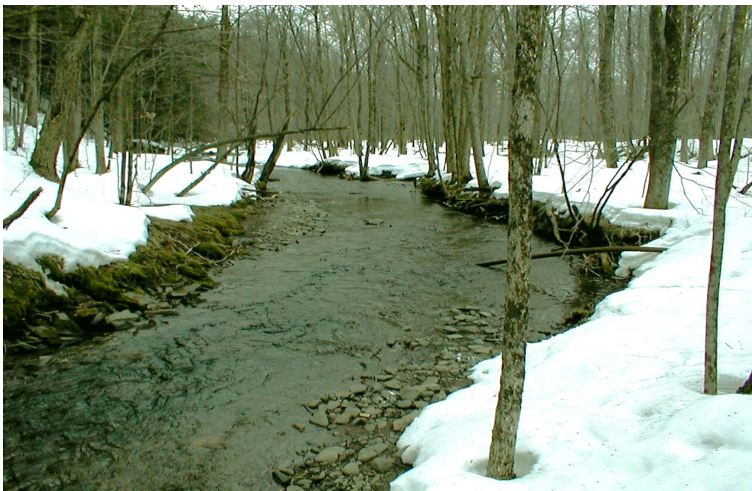
Reference Reach 1.6 Excellent example of a medium gradient woodland Rosgen b4 stream of reference reach quality with an excellent riparian zone. Dominant substrate is coarse gravel.

Geomorphic cluster: deviation from bankfull 10, channel condition 10, hydrologic alteration 10, bank stability 10

Fisheries cluster: pool status 10, instream fish cover 5, riparian zone 10, canopy 10, fish barriers 10

Water quality cluster: water appearance 10, nutrient enrichment 10,

Invertebrate cluster: invertebrate habitat 10

SVAP Aggregate score: 115/12 items scored = 9.6 (excellent)

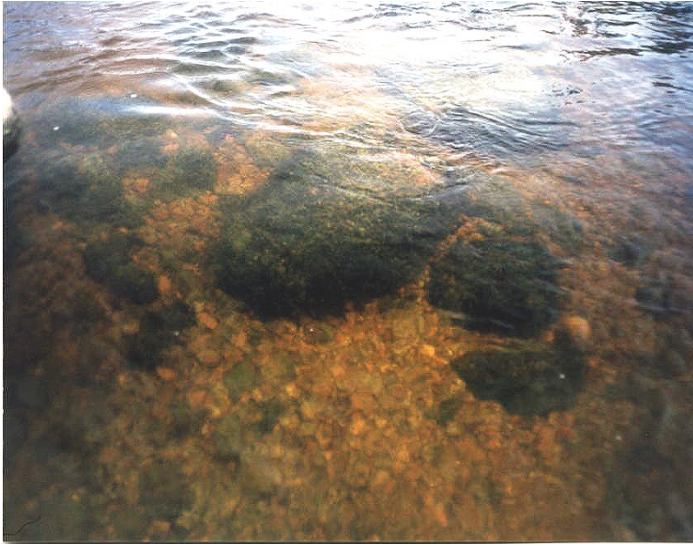
Reference Riffle Embeddedness = 10

This is < 20% embedded, typical for remote B3 streams with intact watersheds.
