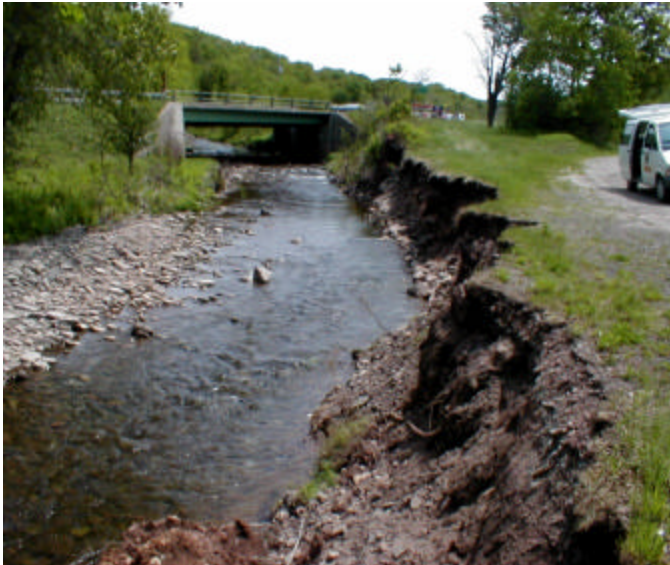
Geomorphic cluster: deviation from bankfull 3, channel condition 3, hydrologic alteration 7, bank stability 1

Fisheries cluster: pool status 1, instream fish cover 1, riparian zone 1, canopy 1, fish barriers 10

Water quality cluster: water appearance 10, nutrient enrichment 10,

Invertebrate cluster: invertebrate habitat 3

SVAP Aggregate score: 44/12 items scored = 3.7 (poor)

key impacts: geomorphic, fisheries, invertebrate

Problem Reach 1.1 Example of a rapidly eroding steep bank on a Rosgen B4 stream reach. Dominant substrate is coarse gravel.

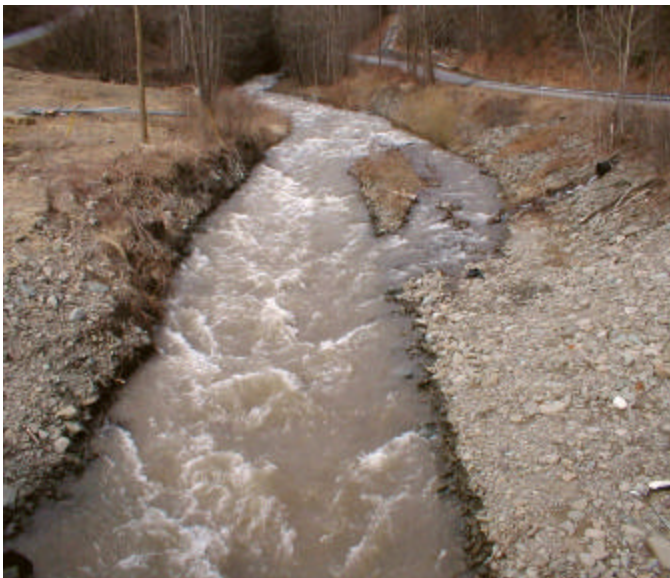
Geomorphic cluster: deviation from bankfull 1, channel condition 1, hydrologic alteration 1, bank stability 1

Fisheries cluster: pool status 1, instream fish cover 1, riparian zone 1, canopy 1, fish barriers 10

Water quality cluster: water appearance 5, nutrient enrichment 10,

Invertebrate cluster: invertebrate habitat 3

SVAP Aggregate score: 36/12 items scored = 3 (poor)

key impacts: geomorphic, fisheries, invertebrate

Problem Reach 1.2 example of an over straight, confined Rosgen B3 stream reach with eroding left bank & unvegetated deposition on the right. Note also channel widening & an early attempt to regain sinuosity following channelization. Dominant substrate is cobble. (photo shot from bridge)

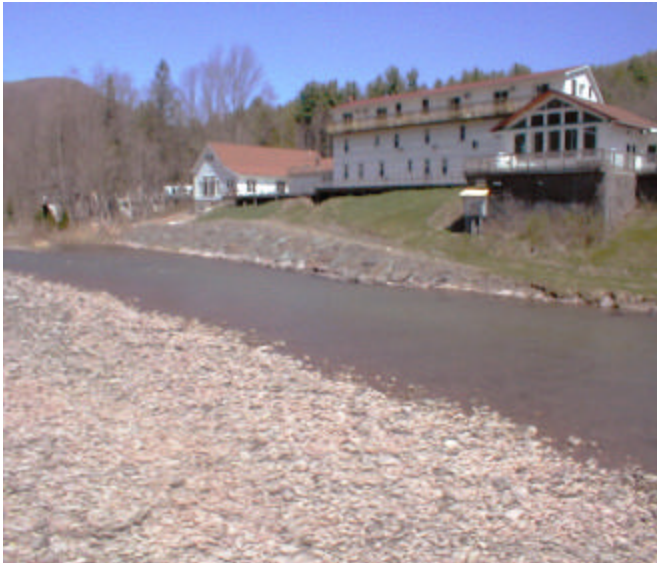
Geomorphic cluster: deviation from bankfull 1, channel condition 1, hydrologic alteration 10, bank stability 3

Fisheries cluster: pool status 1, instream fish cover 1, riparian zone 1, canopy 1, fish barriers 10

Water quality cluster: water appearance 5, nutrient enrichment 10

Invertebrate cluster: invertebrate habitat 3

SVAP Aggregate Score: 47/12 items scored = 3.9 (poor)

key impacts: geomorphic, fisheries, invertebrate

Problem Reach 1.3 Example of a channelized & over widened reach with rip rap on a Rosgen B4 stream reach. Dominant substrate is coarse gravel.

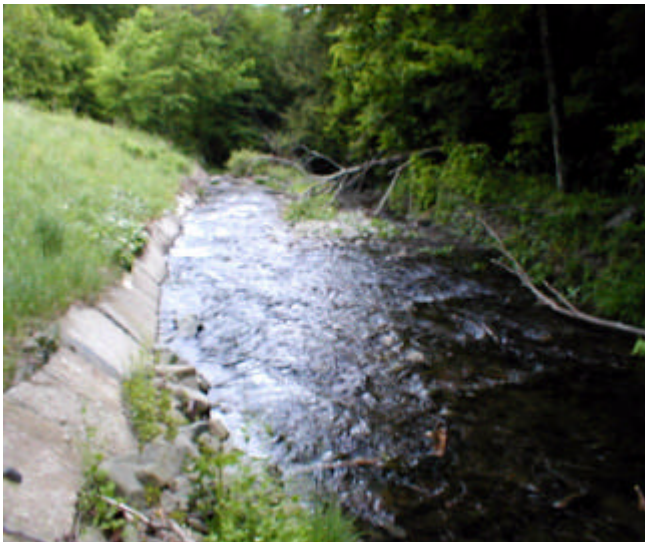
Geomorphic cluster: deviation from bankfull 3, channel condition 3, hydrologic alteration 7,

Fisheries cluster: pool status 1, instream fish cover 1, riparian zone 7, canopy 3, fish barriers 10

Water quality cluster: water appearance 10, nutrient enrichment 10,

Invertebrate cluster: invertebrate habitat 7

SVAP Aggregate score: 42/11 items scored = 3.8 (poor)

key impacts: geomorphic, fisheries, invertebrate

rap & channel straightening on a Rosgen B3 stream. Dominant substrate is cobble.

Problem Reach 1.4 Example of concrete rip

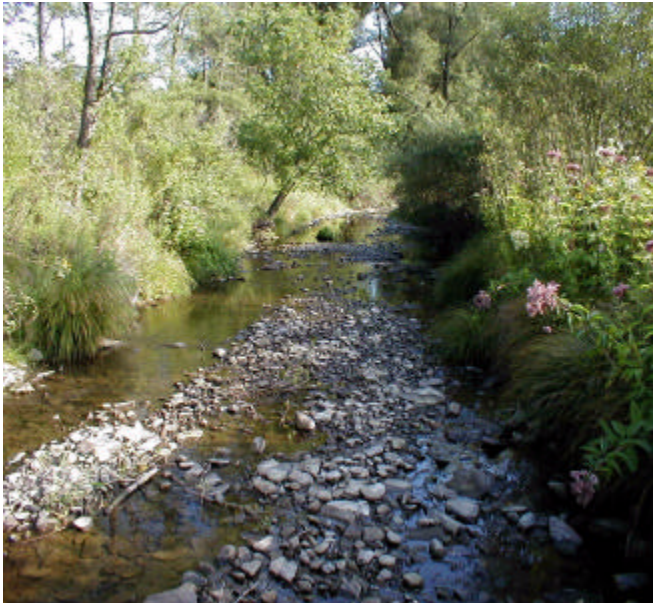
Geomorphic cluster: deviation from bankfull 1, channel condition 3 (aggradation criterion), hydrologic alteration 7, bank stability 10

Fisheries cluster: pool status 1, instream fish cover 1, riparian zone 10, canopy 3, fish barriers 10

Water quality cluster: water appearance 10, nutrient enrichment 10,

Invertebrate cluster: invertebrate habitat 7

Aggregate score: 73/12 items scored = 6.1 (fair)

key impacts: geomorphic, fisheries

Problem Reach 1.5 Example of an aggrading over wide reach on a Rosgen C4 stream during extreme low flow conditions. Dominant substrate is coarse gravel.

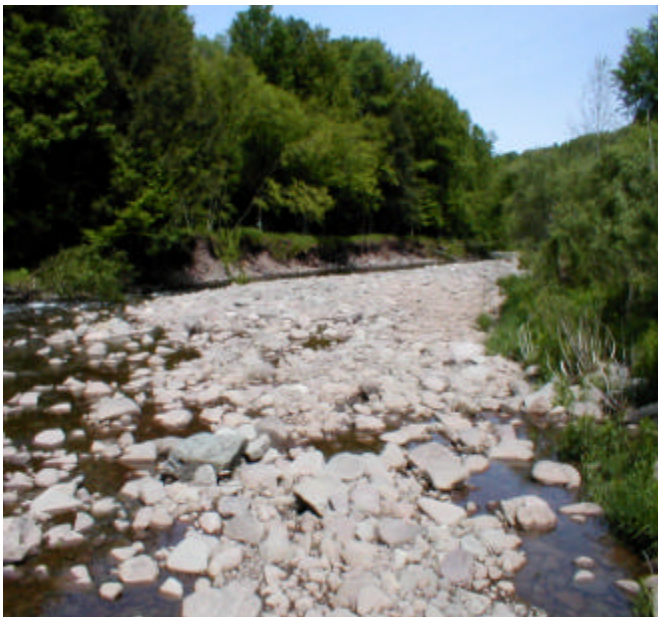
Geomorphic cluster: deviation from bankfull 1, channel condition 3, (aggradation criterion), hydrologic alteration 7, bank stability 3

Fisheries cluster: pool status 7, instream fish cover 3, riparian zone 10, canopy 1

Water quality cluster: water appearance 10, nutrient enrichment 10,

Invertebrate cluster: invertebrate habitat 7

Aggregate score: 62/11 items scored = 5.6 (poor)

key impacts: geomorphic, fisheries

Problem Reach 1.6 Example of an aggrading over wide reach on a Rosgen B3 stream during extreme low flow conditions. Note erosion on left bank. Dominant substrate is cobble.

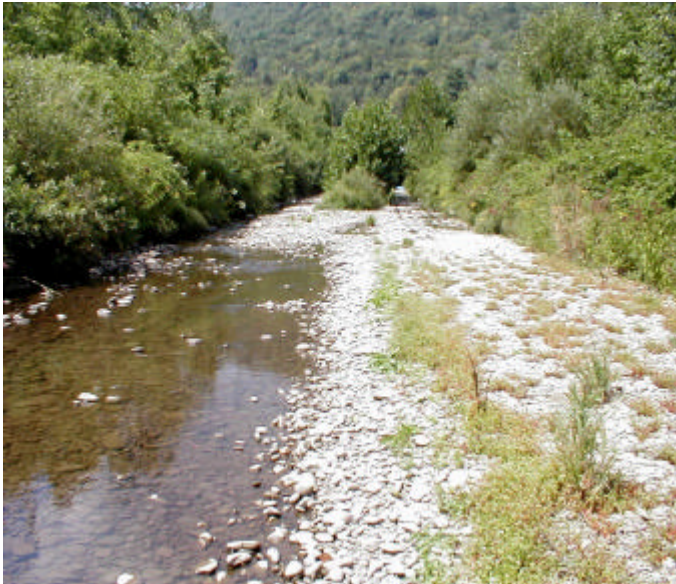
Geomorphic cluster: deviation from bankfull 1, channel condition 3 (aggradation criterion & channelized), hydrologic alteration 3, bank stability 10

Fisheries cluster: pool status 1, instream fish cover 1, riparian zone 10, canopy 1

Water quality cluster: water appearance 10, nutrient enrichment 10

Invertebrate cluster: invertebrate habitat 3

SVAP Aggregate score: 33/11 items scored = 1.1 (poor)

key impacts: geomorphic, fisheries

Problem Reach 1.7 Example of a bulldozed, aggrading over wide reach without pools on a Rosgen C4 stream during extreme low flow conditions. Dominant substrate is coarse gravel. (Note transitioning back to more stable channel dimensions in the background.)

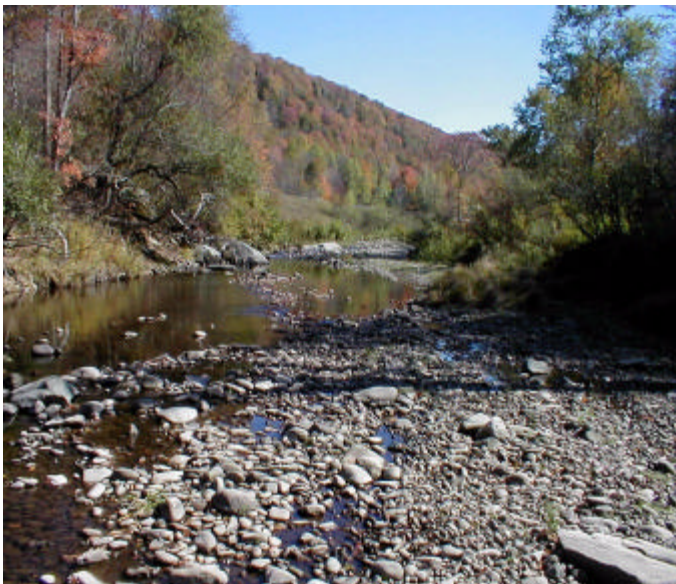
Geomorphic cluster: deviation from bankfull 1, channel condition 3 (aggradation criterion), hydrologic alteration 10, bank stability 10

Fisheries cluster: pool status 7, instream fish cover 3, riparian zone 10, canopy 1

Water quality cluster: water appearance 10, nutrient enrichment 10

Invertebrate cluster: invertebrate habitat 7

SVAP Aggregate score: 72/11 items scored = 6.5 (fair)

key impacts: geomorphic, fisheries

Problem Reach 1.8 Example of an over wide reach, aggrading on a Rosgen B4 stream during extreme low flow conditions. Dominant substrate is very coarse gravel.
