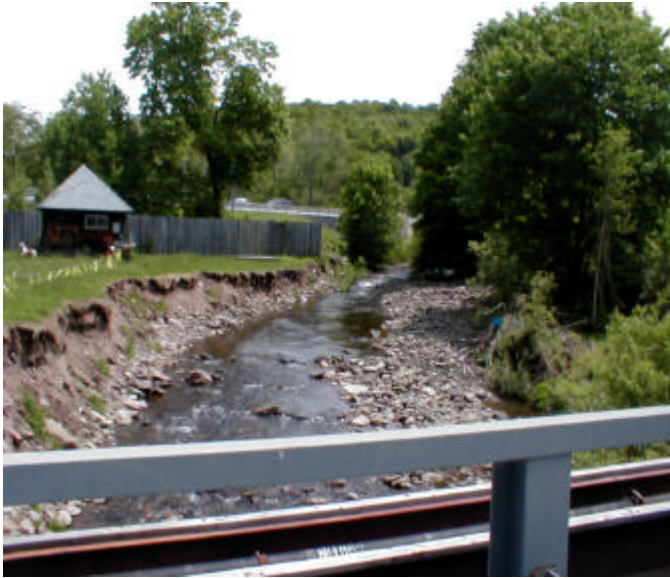
Geomorphic cluster: deviation from bankfull 1, channel condition 1, hydrologic alteration 1, bank stability 1

Fisheries cluster: pool status 1, instream fish cover 1, riparian zone 1, canopy 1

Water quality cluster: water appearance 10, nutrient enrichment 10,

Invertebrate cluster: invertebrate habitat 3

SVAP Aggregate score: 31/11 items scored = 2.8 (poor)

key impacts: geomorphic, fisheries, invertebrate

Problem Reach 3.3 Example of downstream erosion, widening & pool loss from an undersized bridge producing a flume effect (with high/erosive velocities) under high water conditions – worsened by the absence of a riparian buffer!

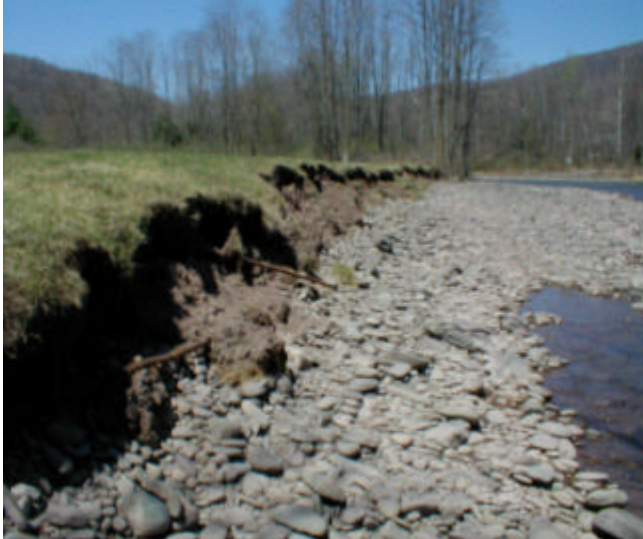
Geomorphic cluster: deviation from bankfull 10, channel condition 3, hydrologic alteration 3, bank stability 7

Fisheries cluster: pool status 7, instream fish cover 7, riparian zone 1, canopy 1

Water quality cluster: water appearance 10, nutrient enrichment 10,

Invertebrate cluster: invertebrate habitat 7

SVAP Aggregate score: 66/11 items scored = 6 (fair)

key impacts: geomorphic > fisheries

Problem Reach 3.3 Example of erosion on an inside bend on a Rosgen F4 stream due to tree removal with a loss of protective root systems.

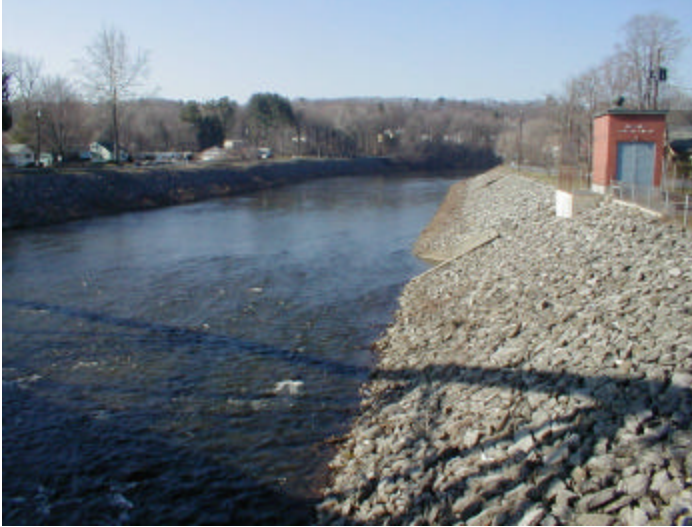
Geomorphic cluster: deviation from bankfull 1, channel condition 1, hydrologic alteration 1, bank stability 7

Fisheries cluster: pool status 1, instream fish cover 1, riparian zone 1, canopy 1

Water quality cluster: water appearance 5, nutrient enrichment 10,

Invertebrate cluster: invertebrate habitat 7

SVAP Aggregate score: 32/11 items scored = 2.9 (poor)

key impacts: geomorphic, fisheries

Problem Reach 3.5 Example of a channelized, leveed, rip rapped F3 stream reach

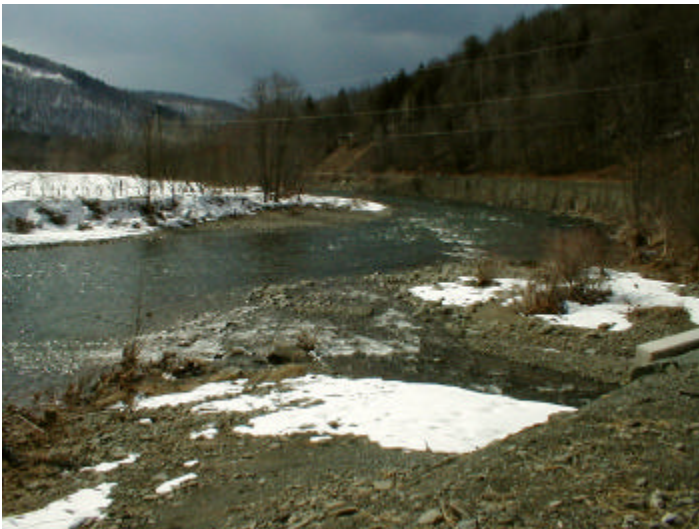
Geomorphic cluster: deviation from bankfull 1, channel condition 1, hydrologic alteration 1, bank stability 7

Fisheries cluster: pool status 1, instream fish cover 1, riparian zone 1, canopy 1

Water quality cluster: water appearance 5, nutrient enrichment 10,

Invertebrate cluster: invertebrate habitat 3

SVAP Aggregate score: 32/11 items scored = 2.9 (poor)

key impacts: geomorphic, fisheries

Problem Reach 3.6 Example of a large delta deposit from the small stream entering from the right, an indicator of excessive bedload transport. Note how the main stream has had to adjust to this sediment input by shifting the entire channel leftward and modifying its pool.

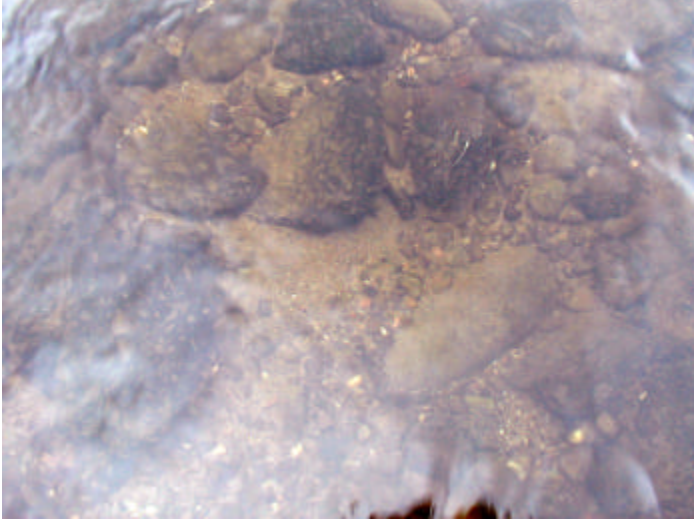
Problem Reach

Riffle Embeddeness = 3 Note sand between the cobbles and partially covering the gravel
gravel is > 40% embeddeness
